# Manhole Inspection Summary

Manhole # S51I\_\_022MH

Insp Date: **4/2/08 1:37 PM**

**Location** Address: **500 Eastern Av**

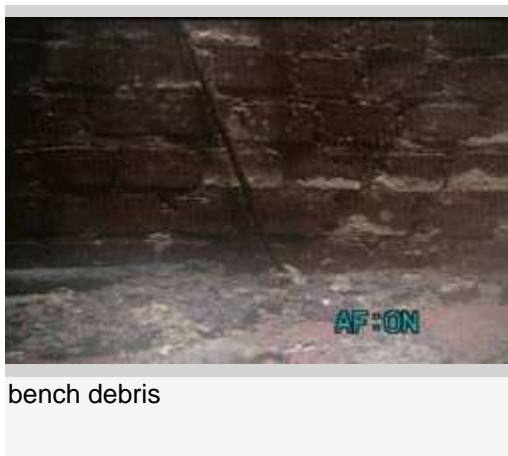
Defect 4

bench debris

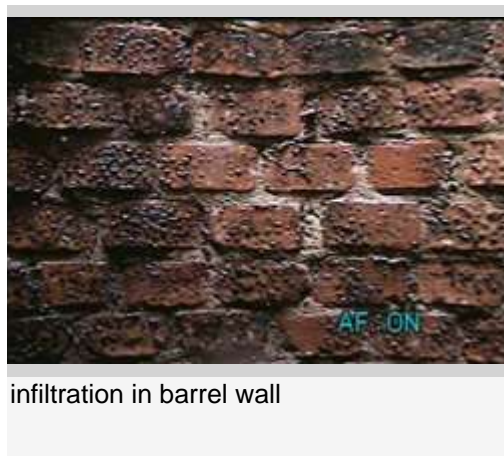
Defect 4

Infiltration: ☐ None ☐ Joint ☐ Cracks ☐ Mortar ☐ Roots ☒ **Wall**

infiltration in barrel wall

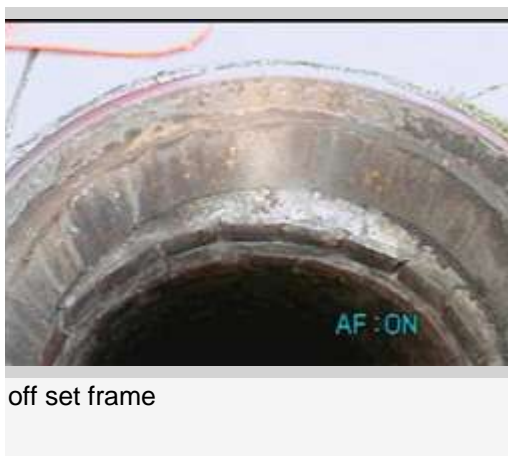
Defect 2

Offset: **3** (in.)

off set frame

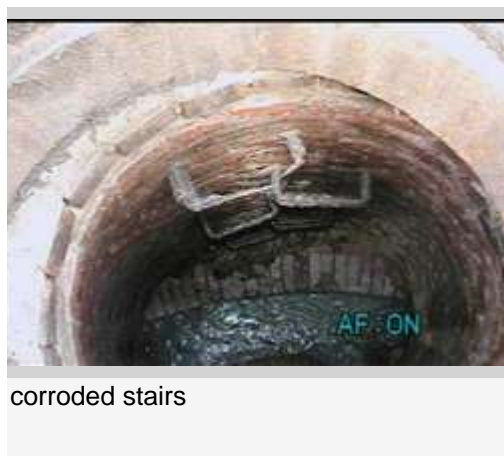
Defect 1

Count: **5** Missing: **0** ☒ **Corroded**

corroded stairs
